Stormwater Outfall Monitoring Program

Two year summary | May 2023

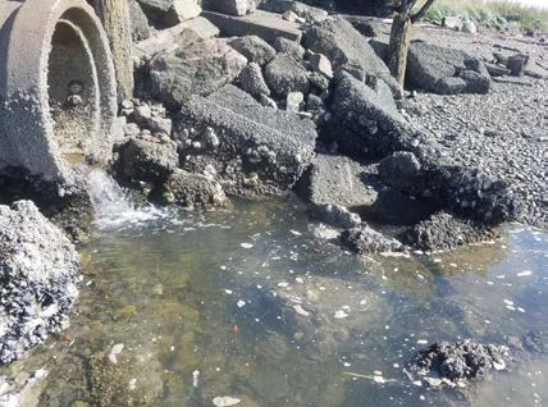
1. Broadway Street Outfall:

Photo of Outfall:	Approximate drainage area:

Number of Exceedances:			Parameter	2021	2022	<i>Color</i>	2	3	<i>Visual</i>	0	3	<i>Conduct</i>	0	2	<i>E. coli</i>	1	3
Number of Exceedances:																			
Parameter	2021	2022																	
<i>Color</i>	2	3																	
<i>Visual</i>	0	3																	
<i>Conduct</i>	0	2																	
<i>E. coli</i>	1	3																	
<p>Rating: Watch</p>

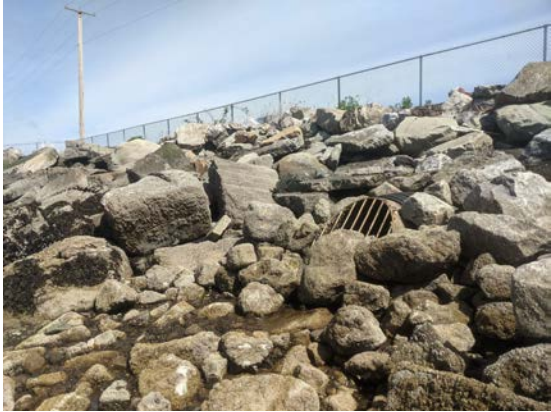
3. Cornwall Avenue Outfall:

Photo of Outfall:	Approximate drainage area:

Number of Exceedances:			Parameter	2021	2022	<i>Color</i>	1	1	<i>DO</i>	1	3	<i>E. coli</i>	2	3
Number of Exceedances:																
Parameter	2021	2022														
<i>Color</i>	1	1														
<i>DO</i>	1	3														
<i>E. coli</i>	2	3														
<p>Rating: Watch</p>

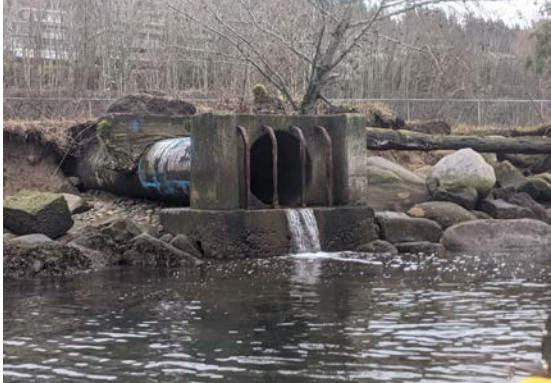
4. Cedar Street Outfall:

Photo of Outfall:	Approximate drainage area:

Number of Exceedances:			Parameter	2021	2022	<i>Color</i>	0	4	<i>Odor</i>	1	3	<i>Visual</i>	0	1	<i>Conduct</i>	8	8	<i>E. coli</i>	2	8
Number of Exceedances:																						
Parameter	2021	2022																				
<i>Color</i>	0	4																				
<i>Odor</i>	1	3																				
<i>Visual</i>	0	1																				
<i>Conduct</i>	8	8																				
<i>E. coli</i>	2	8																				
<p>Rating: Threat</p>

The continued high conductivity readings at the Cedar outfall are still unknown. However, the salinity readings are on average 0.30 ppt and may explain the high conductivity readings. This outfall is also plagued with high *E. coli* counts, as well as abnormal odors, color, and visuals. A strong sulfur smell has been documented on occasion along with discolored water and the presence of a white microbial mat similar to the one noted at C Street outfall.

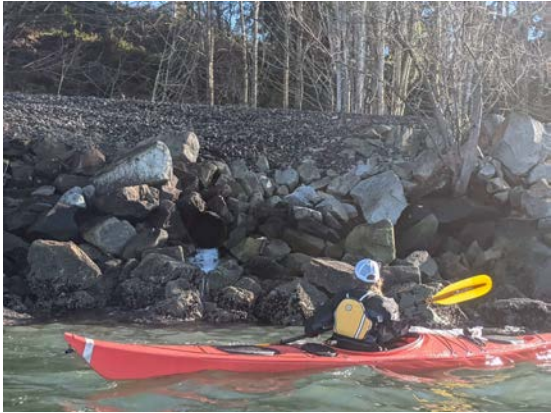
5. Boulevard Outfall:

Photo of Outfall:	Approximate drainage area:

Number of Exceedances:			Parameter	2021	2022	<i>Outflow</i>	0	1	<i>Color</i>	0	1	<i>Turbidity</i>	0	1	<i>E. coli</i>	5	4
Number of Exceedances:																			
Parameter	2021	2022																	
<i>Outflow</i>	0	1																	
<i>Color</i>	0	1																	
<i>Turbidity</i>	0	1																	
<i>E. coli</i>	5	4																	
<p>Rating: Threat</p>

On August 25, 2022, an illicit discharge was noted at the Boulevard outfall (also referred to as Olive St. outfall). The water was extremely turbid, rushing out of the pipe, and discolored the entire bay. The discharge was reported but no follow up information was provided.

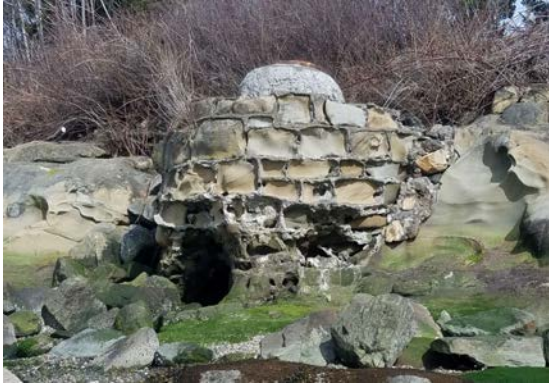
6. Bennett Street Outfall:

Photo of Outfall:	Approximate drainage area:

Number of Exceedances:			Parameter	2021	2022	<i>Visual</i>	0	2	<i>E. coli</i>	12	8
Number of Exceedances:													
Parameter	2021	2022											
<i>Visual</i>	0	2											
<i>E. coli</i>	12	8											
<p>Rating: Threat</p>

Chronic, high bacteria counts continue to plague several of the outfalls and creeks. The average *E. coli* count for the Bennett outfall for 2021 and 2022 combined seasons is 2,343 coliform forming units per 100 ml (cfu/100 ml). This is 7 times the 320 cfu/100 ml *E. coli* standard set for recreational waters in Washington State. While there were fewer bacterial exceedances at the Bennett outfall in 2022 than in 2021, the exceedances were more extreme. The average *E. coli* sample in 2021 was 1,162 cfu/100 ml and in 2022 it was 3,818 cfu/100 ml. In 2022, the R-card replaced the Coliscan EasyGel as the method to culture and measure bacteria. The R-card is less ambiguous in identifying colonies and may, in part, explain the increase in numbers. But because the difference is so dramatic, there is likely an additional, environmental cause.

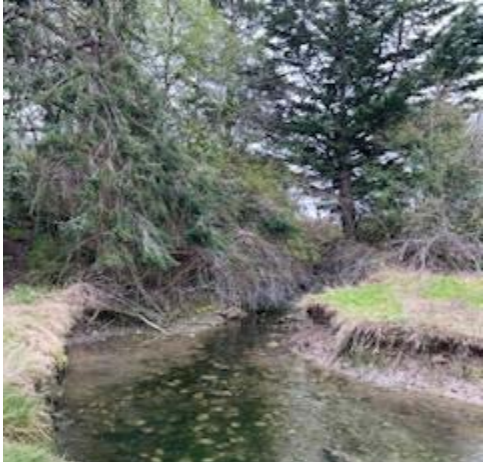
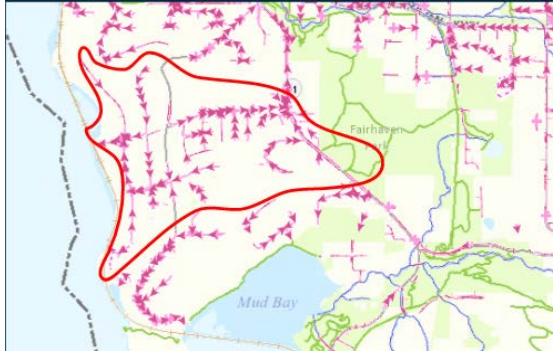
7. Willow Street Outfall:

Photo of Outfall:	Approximate drainage area:

Number of Exceedances:		Parameter	2022	<i>DO</i>	1	<i>E. coli</i>	1
Number of Exceedances:									
Parameter	2022								
<i>DO</i>	1								
<i>E. coli</i>	1								
<p>Rating: Good</p>

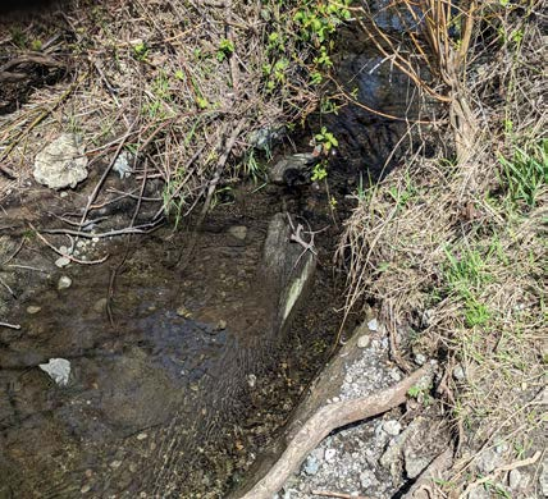
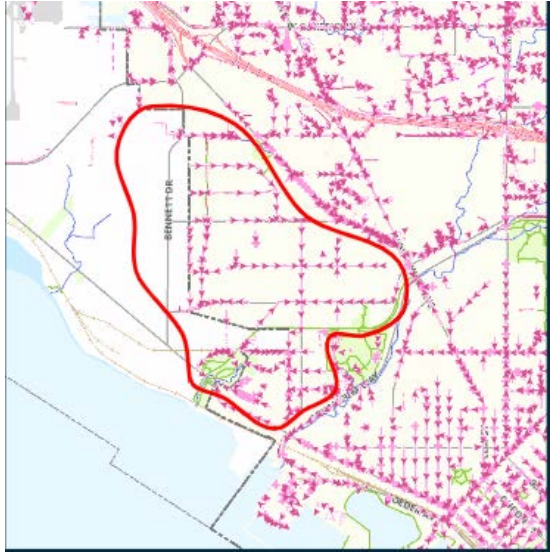
1. **Little Squalicum Creek** (only 5 data points):

Photo of Creek:	Approximate drainage area:

Number of Exceedances:		Parameter	2022	<i>Color</i>	1	<i>E. coli</i>	1
Number of Exceedances:									
Parameter	2022								
<i>Color</i>	1								
<i>E. coli</i>	1								
Rating: Watch

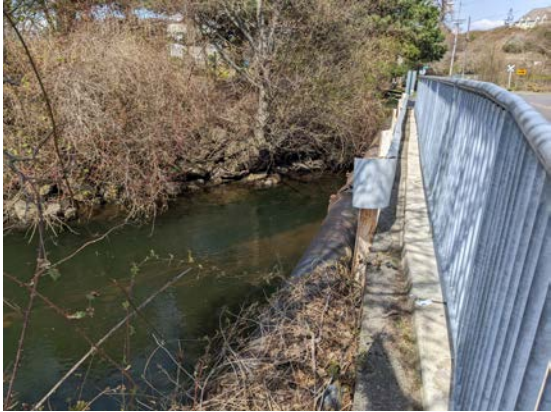
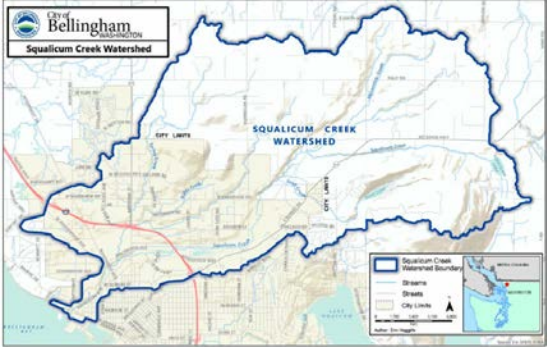
2. Squalicum Creek:

Photo of Creek:	Approximate drainage area:

Number of Exceedances:			Parameter	2021	2022	<i>Color</i>	7	10	<i>Visual</i>	6	6	<i>DO</i>	1	0	<i>pH</i>	1	1	<i>Turbidity</i>	3	0	<i>E. coli</i>	1	5
Number of Exceedances:																									
Parameter	2021	2022																							
<i>Color</i>	7	10																							
<i>Visual</i>	6	6																							
<i>DO</i>	1	0																							
<i>pH</i>	1	1																							
<i>Turbidity</i>	3	0																							
<i>E. coli</i>	1	5																							
<p>Rating: Threat</p>

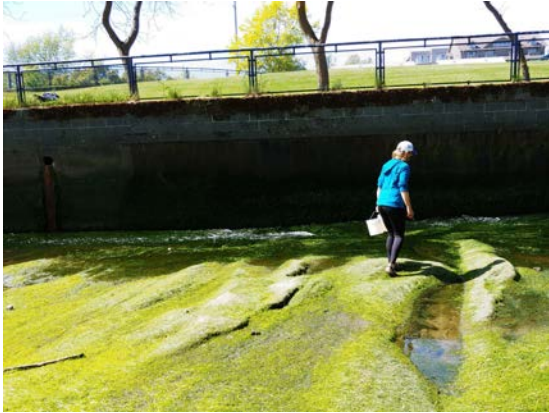
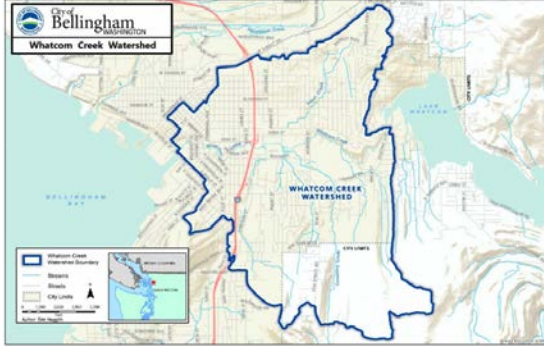
3. Whatcom Creek:

Photo of Creek:	Approximate drainage area:

Number of Exceedances:			Parameter	2021	2022	<i>Color</i>	0	1	<i>Odor</i>	0	1	<i>Temp</i>	4	4	<i>DO</i>	0	1	<i>pH</i>	0	2	<i>Turbidity</i>	0	1	<i>E. coli</i>	3	4
Number of Exceedances:																												
Parameter	2021	2022																										
<i>Color</i>	0	1																										
<i>Odor</i>	0	1																										
<i>Temp</i>	4	4																										
<i>DO</i>	0	1																										
<i>pH</i>	0	2																										
<i>Turbidity</i>	0	1																										
<i>E. coli</i>	3	4																										
<p>Rating: Threat</p>

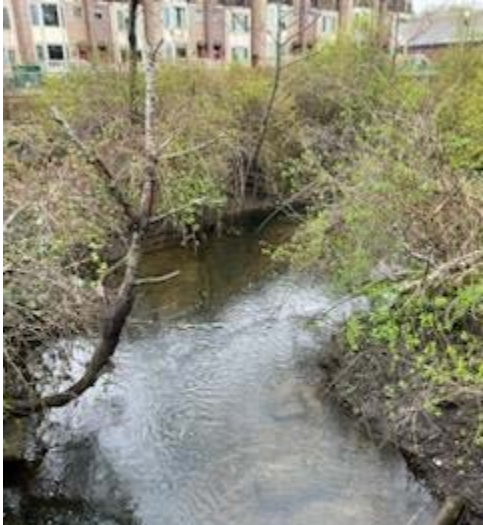
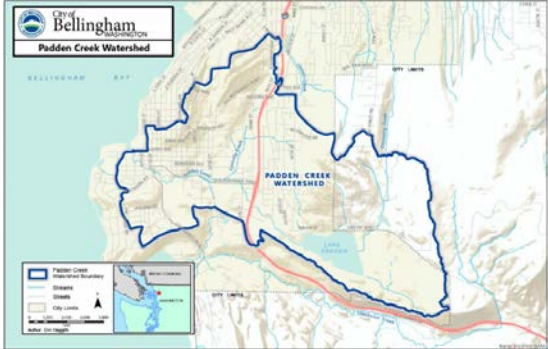
4. Padden Creek:

Photo of Creek:	Approximate drainage area:

Number of Exceedances:		Parameter	2022	<i>Color</i>	7	<i>Visual</i>	3	<i>Temp</i>	2	<i>DO</i>	1	<i>Conduct</i>	2	<i>E. coli</i>	4
Number of Exceedances:																	
Parameter	2022																
<i>Color</i>	7																
<i>Visual</i>	3																
<i>Temp</i>	2																
<i>DO</i>	1																
<i>Conduct</i>	2																
<i>E. coli</i>	4																
<p>Rating: Threat</p>
